Implementation of Multiple Measures to Improve Reactor Recirculation Pump Sealing Performance in Nuclear Boiling Water Reactor Service

Gerard van Loenhout and Jürg Hurni

This paper describes the sudden increase in stray current activity leading to rapid deterioration of the mechanical end face shaft seal in a reactor recirculation pump. The problem accelerated after the installation of new variable frequency drives replacing the original motor-generator sets. As a result of the seal face damages incurred, two short unscheduled outages were required to refurbish the mechanical seal and continue power station operation.

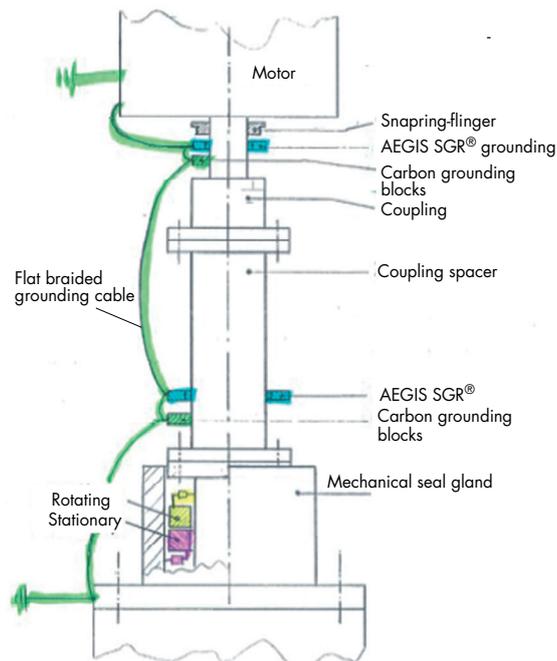
Fig. 7. Concept sketch grounding system RRP's.

Figure 7 shows the initial concept sketch as it was drawn up and used for discussion purposes.

Advanced Materials (the blue colour pieces in **Figure 7**). This is a 360 ° ring made from electrically conductive aluminum installed around the shaft. The metal ring contains rows of highly conductive microfibers, which have full 360 ° circumferential contact with the shaft. The AEGIS® SGR is mounted in an aluminum bracket to the motor housing. A colloidal silver shaft coating is applied on the shaft to ensure a good conductive path between shaft and microfibers. This particular device is used to handle potential high frequency currents, which may flow downwards from the motor. The aluminum mounting bracket is grounded to the stations grounding system by means of a new flat braided grounding cable, also made from aluminum.

Beneath the SGR, a set of two carbon grounding blocks has been installed which also ground the same motor shaft (the green colour pieces in **Figure 7**). The use of these devices is to potentially handle all low frequency currents flowing down the motor shaft. The carbon graphite grounding blocks are connected to the aluminum installation bracket of the SGR by a separate grounding cable.

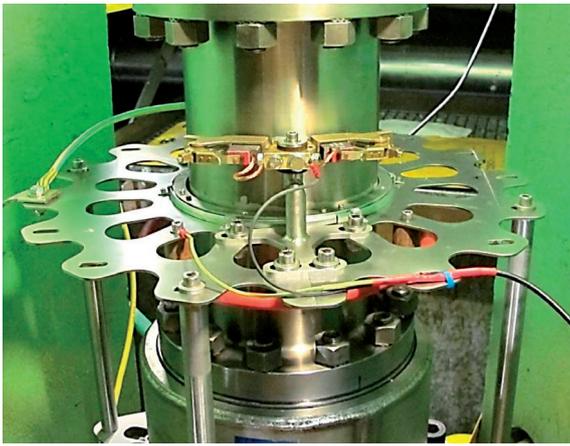
Fig. 8.
Measurement and grounding system at the coupling spool piece area.

Figure 8 shows the system set up around the coupling spool piece area.

Further down the coupling spool piece a similar set up is made. An aluminum installation plate is positioned around the spool piece and mounted on spacer rods connected to the seal gland below. On top of this installation plate a set of 2 carbon graphite grounding blocks have been installed. These blocks are electrically insulated from ground and serve as contact sensors for the shaft voltage measurement. A cable is fed outside the reactor drywell to allow remote measurements by station personnel during plant operation. On the opposite side a second set of carbon graphite grounding blocks are installed which are connected with a

Beneath the carbon graphite grounding blocks touching the coupling spool piece is another AEGIS® SGR clamped in the mentioned aluminum installation plate. This SGR acts as a redundant device for potential high frequency currents that may flow downwards from the motor.

Finally, located under the aluminum installation plate sits a Rogowski coil, which is used for measuring shaft currents and which has been calibrated for a maximum value of 30 Amperes. The Rogowski coil is electrically insulated from the aluminum installation plate and its cable is fed outside the reactor drywell to allow regular measurements by station personnel.
